**NPDES Baseline Impervious Assessment
Town of Emmitsburg, Frederick County, MD**

General Discharge Permit No. 13-IM-5500
General NDPES No. MDR055500

March 2020

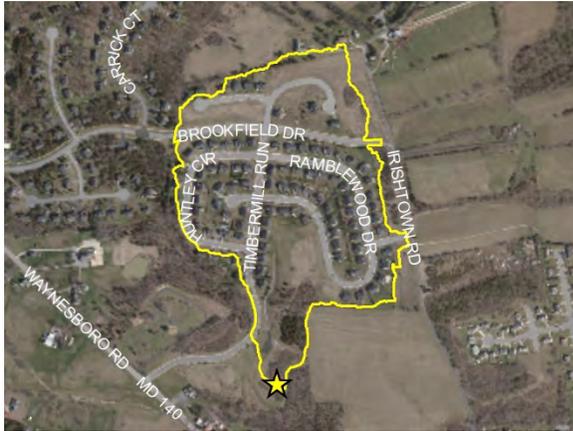
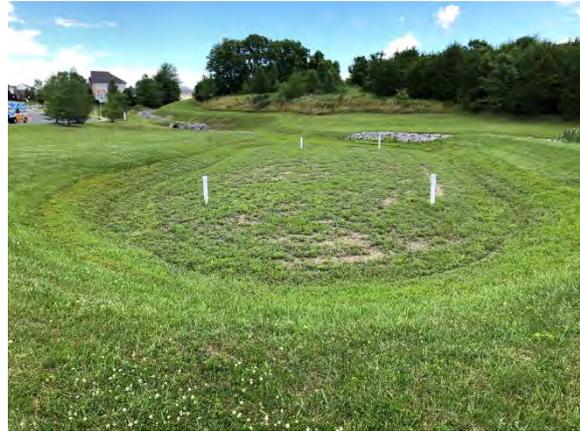
Brookfield Subdivision - SWM Pond (FR15POI000840)

The Brookfield subdivision SWM Pond is a 2012 partial retrofit of an existing quantity control pond constructed in 1990. The design of this retrofit consisted of a forebay, infiltration basin, and wet shallow marsh cell draining into the remaining portion of the quantity control pond. This facility has a total drainage area of 52.58 acres and treats the houses, roads, and other impervious of the Brookfield residential subdivision. Treatment is provided for 14.35 acres of impervious.

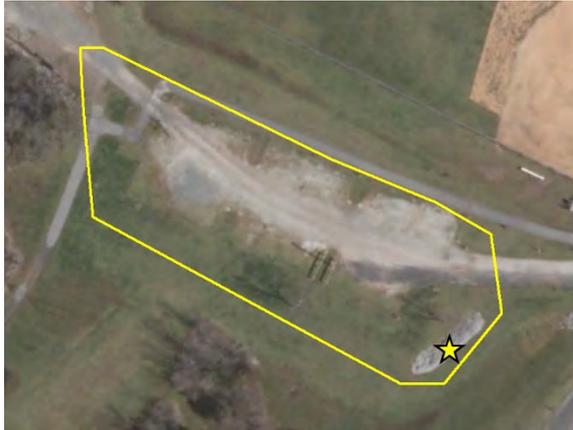
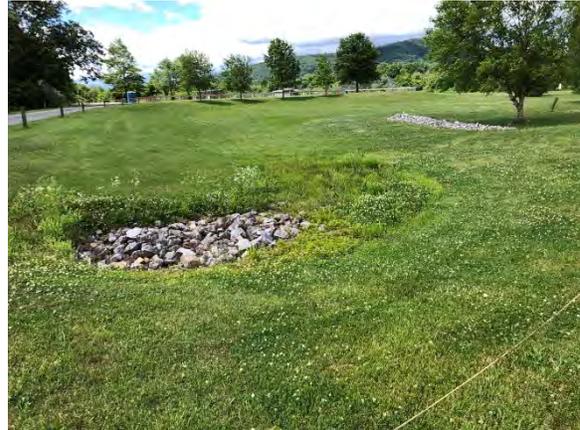
Emmitsburg Community Park - Filtration Basin (FR15POI000238)

The Emmitsburg Community Park infiltration basin was constructed in 2002. The design of this facility consisted of a shallow basin with rock filtration berms. The berms are surrounded by flat grass terrain allowing dispersal and absorption of water. This facility has a total drainage area of 0.55 acres and treats a small gravel parking lot in the Emmitsburg Community Park. Treatment is provided for 0.30 acres of impervious.

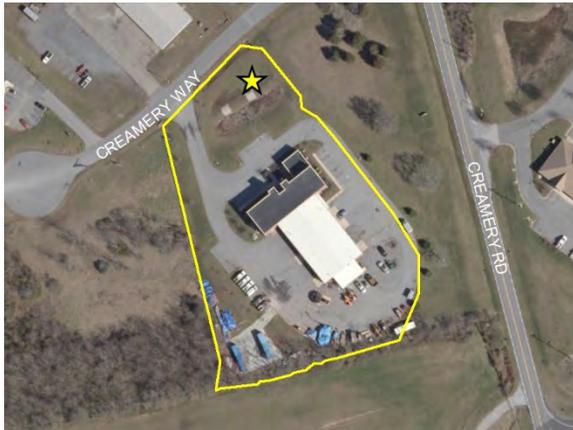
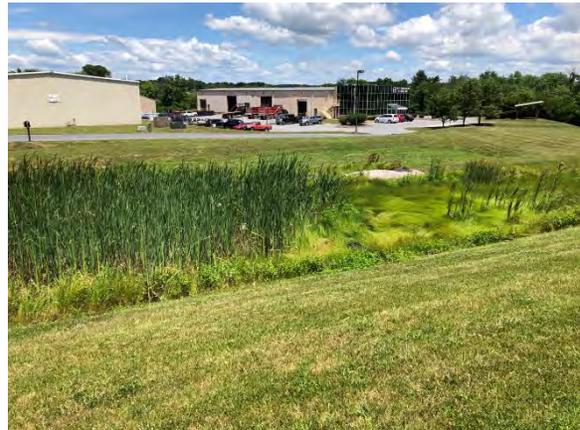
Emmitsburg East Industrial Park, Lot 6 Sand Filter (FR15POI000236)

The Emmitsburg East Industrial Park Lot 6 sand filter was constructed in 2009. The design of this facility consisted of a 2-section water quality pond with a sand filter and underdrain. This facility has a total drainage area of 2.70 acres and treats an industrial building and parking lot on Lot 6 of Emmitsburg East Industrial Park. Treatment is provided for 1.62 acres of impervious.

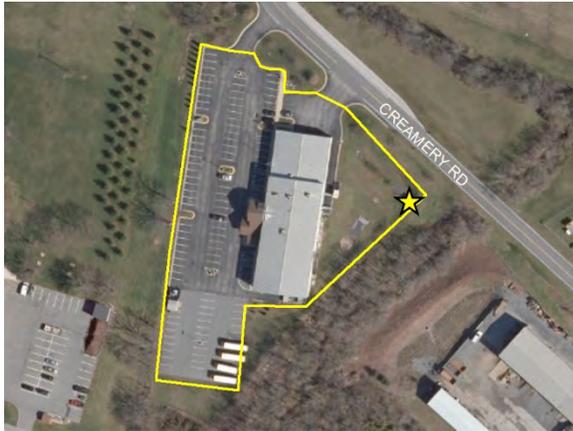
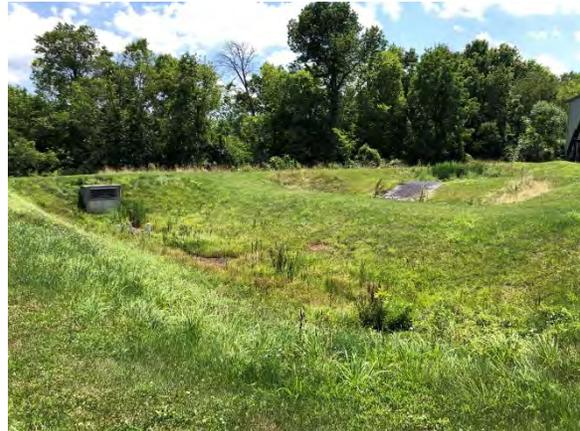
Emmitsburg Volunteer Ambulance - Pond/Sand Filter Facility (FR15POI000263)

Emmitsburg Volunteer Ambulance pond and sand filter was constructed in 2010. The design of this facility consisted of a water quality pond with a sand filter and underdrain. This facility has a total drainage area of 2.01 acres and treats the Volunteer Ambulance structure and parking lot. Treatment is provided for 1.51 acres of impervious.

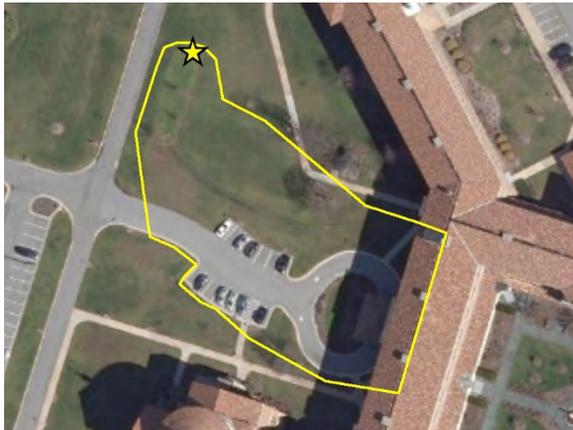
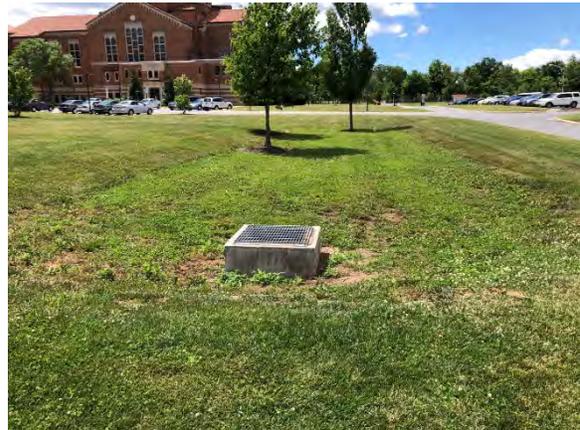
Homes for America @ Seton Village - WQ #1 (FR16POI001016)

The Homes for America @ Seton Village - WQ #1 bioretention was constructed in 2011. The design of this facility consisted of a planted bioretention facility with infiltrative substrate and underdrain. Treatment is supplemented by a small rain garden located near the entrance awning. This facility has a total drainage area of 0.93 acres and treats a cul-de-sac building entrance drop-off and an associated drive with parking of the Seton Village/Provincial House parking lot. Treatment is provided for 0.27 acres of impervious.

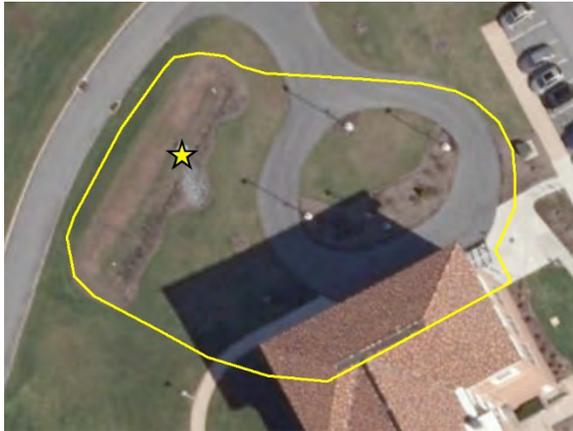
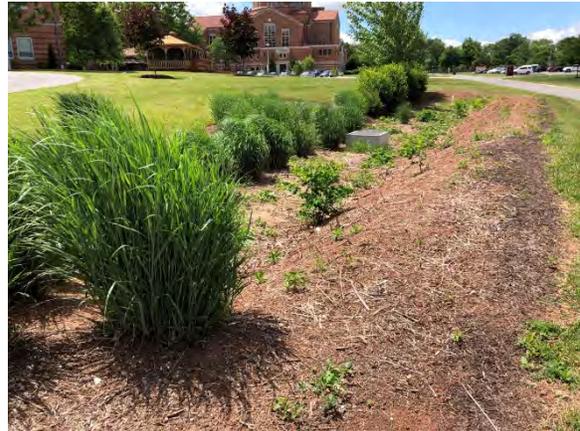
Homes for America @ Seton Village - WQ #2 (FR16POI001017)

The Homes for America @ Seton Village - WQ #2 bioretention was constructed in 2011. The design of this facility consisted of a planted bioretention facility with infiltrative substrate and underdrain. This facility has a total drainage area of 0.44 acres and treats a cul-de-sac building entrance drop-off of the Seton Village/Provincial House parking lot. Treatment is provided for 0.15 acres of impervious.

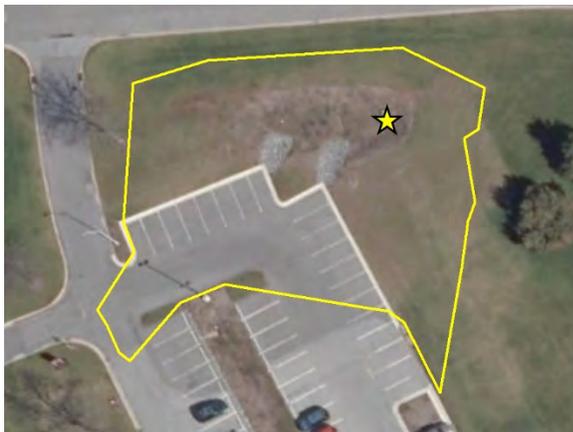
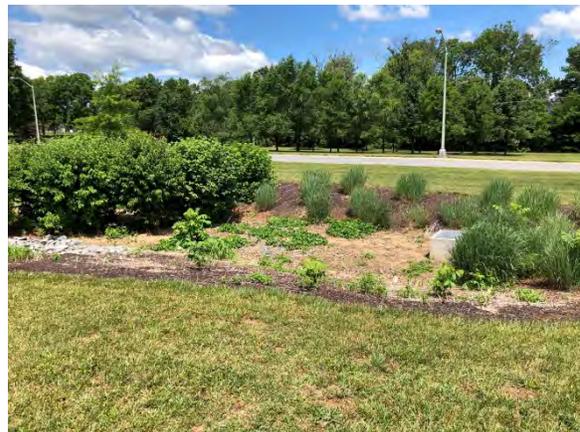
Homes for America @ Seton Village - WQ #3 (FR16POI001018)

The Homes for America @ Seton Village - WQ #3 bioretention was constructed in 2011. The design of this facility consisted of a planted bioretention facility with infiltrative substrate and underdrain. This facility has a total drainage area of 0.45 acres and treats a portion of the Seton Village/Provincial House parking lot. Treatment is provided for 0.13 acres of impervious.

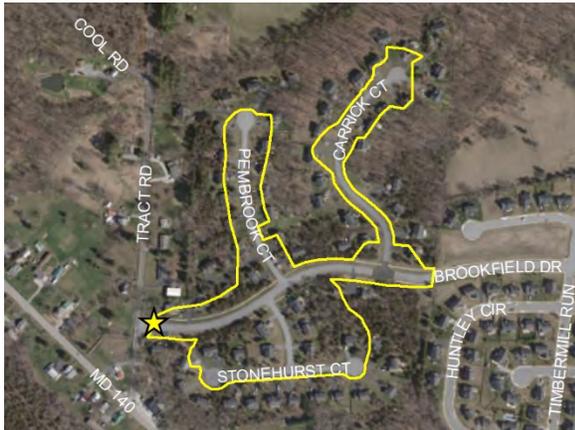
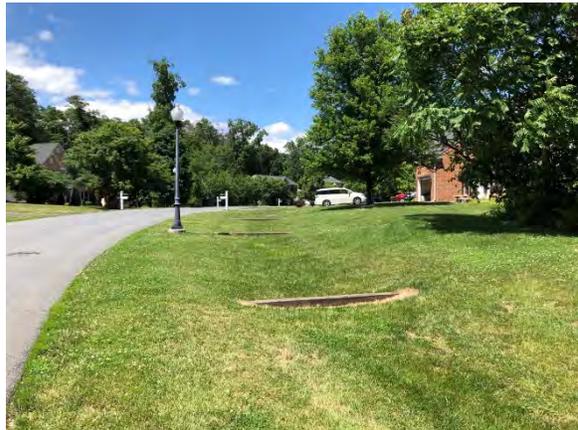
Pembroke Dry Swales (FR15POI000080)

The Pembroke Dry Swales were constructed in 2004. The design consisted of a series of grass swales throughout the Pembroke subdivision. Check dams created with railroad ties embedded in the swales are well maintained and provide flow attenuation and treatment storage. These swales have a total drainage area of 16.08 acres and treat primarily roadway runoff with some contribution from structures in the Pembroke subdivision. Treatment is provided for 5.76 acres of impervious.

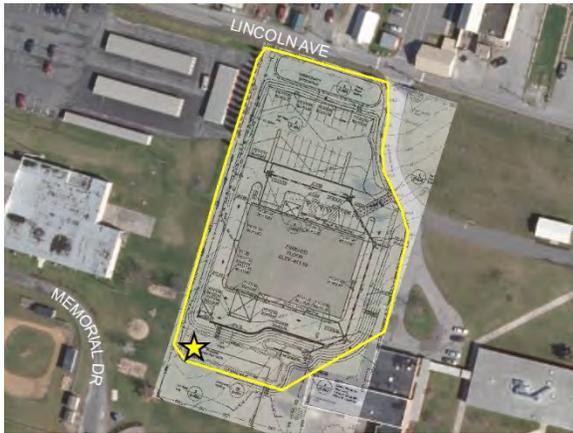
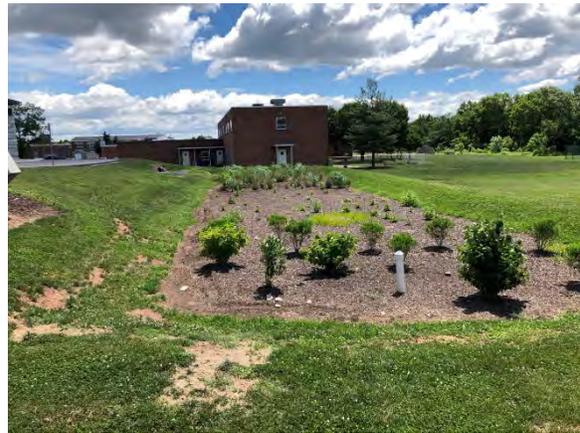
Seton Center - Bioretention Basin (FR18POI162909)

The Seton Center bioretention basin was constructed in 2018. The design of this facility consisted of a forebay and retention basin with an infiltrative substrate. The site is new and did not appear on the impervious maps or aerials, so the impervious area was taken from as-built drawings. This facility has a total drainage area of 1.66 acres and treats the Seton Center structure, access drives, and some parking. A portion of the parking lot is pervious pavement which is not counted in the total impervious area. Treatment is provided for 1.02 acres of impervious.

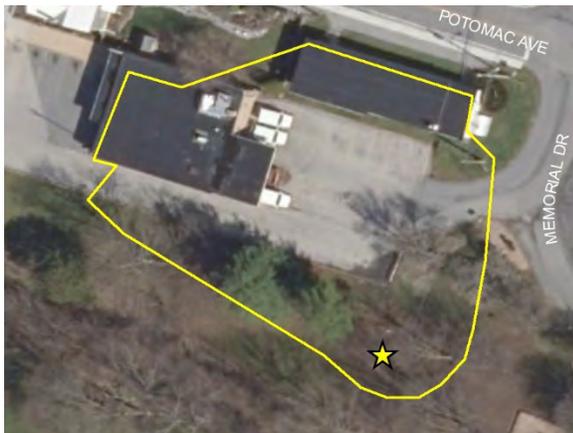
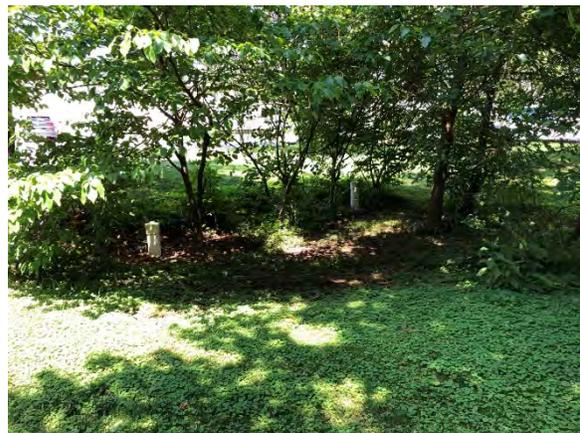
Silo Hill Commercial Development - Off-Site Biofilter (FR15POI000246)

The Silo Hill off-site bioretention facility was constructed in 2002. The design of this facility consisted of a planted bioretention facility with infiltrative substrate and underdrain. This facility has a total drainage area of 0.49 acres and treats the structure and parking lot of the Emmitsburg office of the United States Postal Service. Treatment is provided for 0.29 acres of impervious.

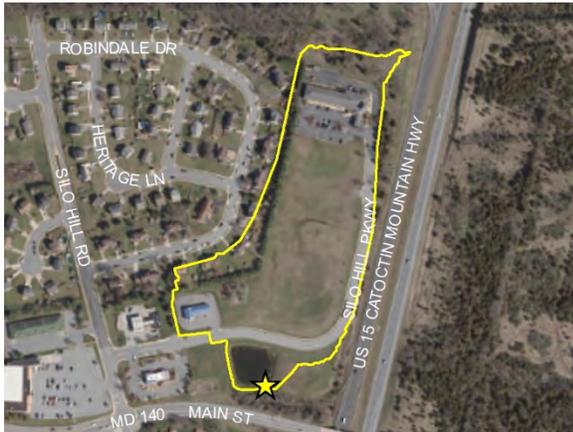
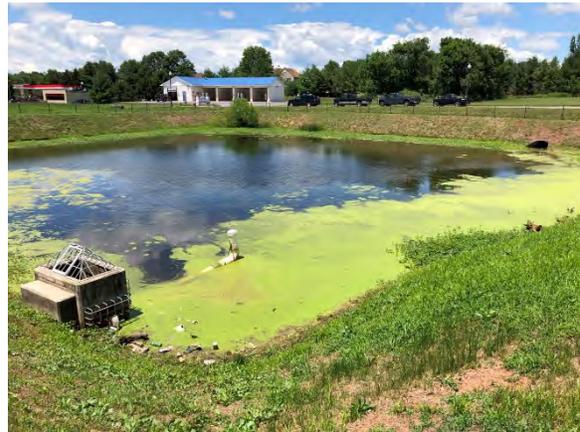
Silo Hill, Ph. 1 (Commercial Sleep Inn & Denny's) (FR15POI000833)

The Silo Hill Phase 1 shallow marsh was constructed in 2000. The design features a wet shallow marsh with micropools. Although constructed before 2002, the design of this facility provided a permanent wet pond with at least 1" WQv treatment. This facility has a total drainage area of 12.85 acres and treats a series of commercial lots, most of which have not been developed. Treatment is provided for 3.26 acres of impervious.

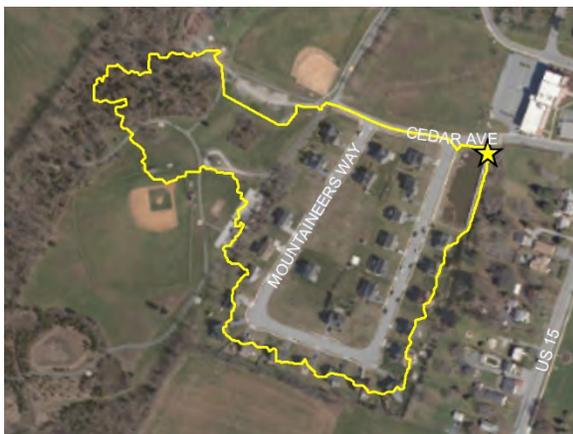
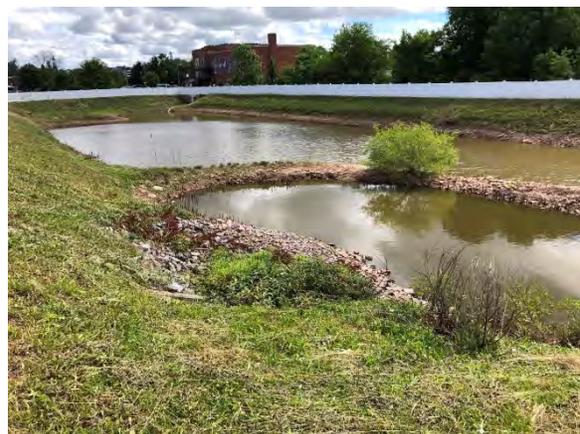
Southgate, Sec. 1 - Shallow Marsh (FR15POI000896)

The Southgate Section 1 shallow marsh was constructed in 2009. The design of this facility consisted of a wet pond with forebays and wetlands plantings. This facility has a total drainage area of 15.95 acres and treats the roads and structures of the Southgate Section 1 subdivision. Treatment is provided for 3.92 acres of impervious.

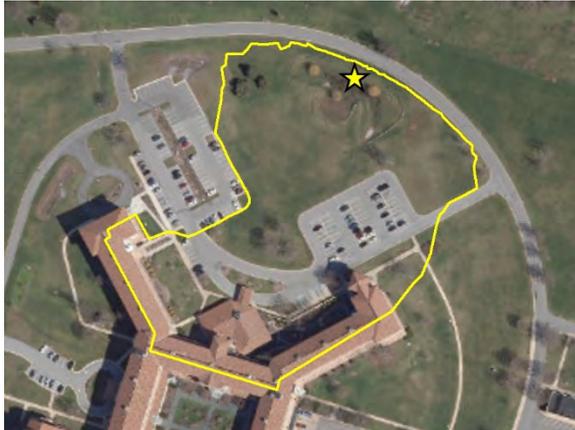
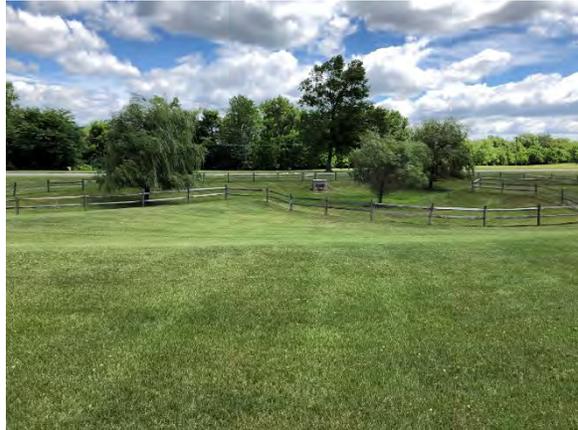
St. Joseph's Provincial House – SWM Pond (FR15POI000204)

The St. Joseph's Provincial House SWM pond was constructed in 2011. The design of this facility consisted of a three-lobe extended-detention wet pond. Although constructed before 2002, the design of this facility provided a permanent wet pond with at least 1" WQv treatment. This facility has a total drainage area of 5.65 acres and treats roads, parking, and partial building runoff from the Provincial House. Treatment is provided for 1.92 acres of impervious.

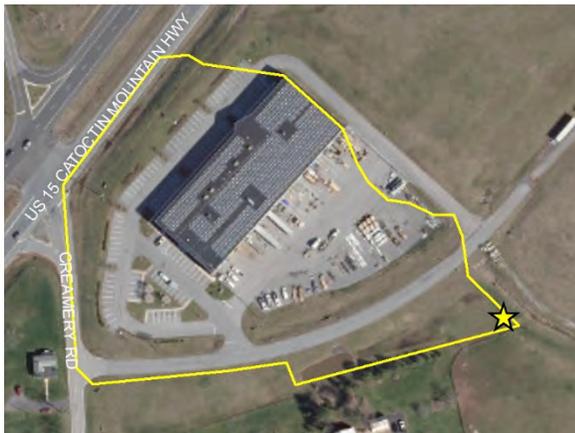
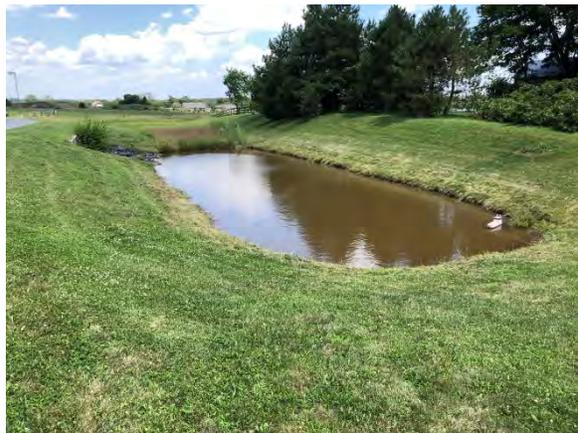
Waybright Property - Sand Filter (FR15POI000719)

The Waybright Property sand filter was constructed in 2008. The design of this facility consisted of a water quality pond with a sand filter with underdrain. This facility has a total drainage area of 6.37 acres and treats an industrial building and parking lot from Emmitsburg Glass. Treatment is provided for 3.83 acres of impervious at the required 1-inch WQv.

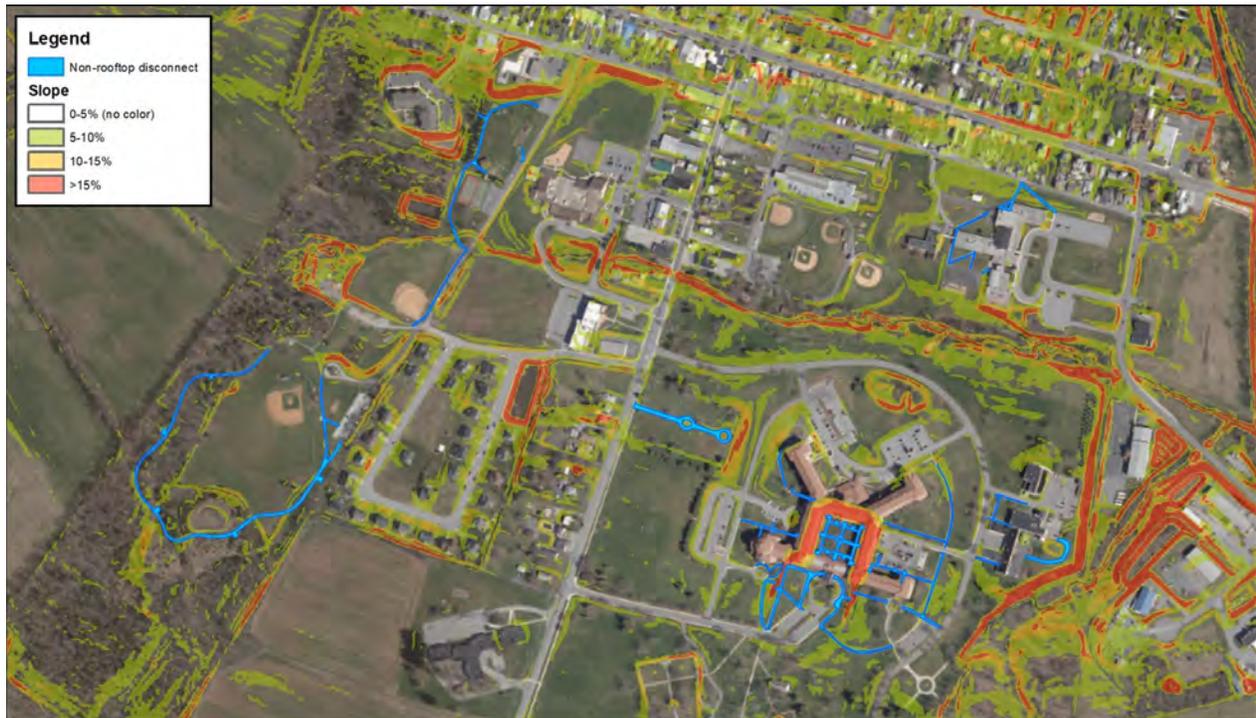
Figure 1 - Example of slope analysis results

The potential areas above were evaluated for N-2: Disconnection of Non-Rooftop Runoff based on the MDE Stormwater Manual design criteria and GIS analysis of slope using the Frederick County DEM. Impervious surfaces were considered adequately treated if they demonstrated sheet flow to pervious surface with slope of 5% or less over a length equal to the contributing length. In areas where a contiguous sidewalk passed over a section of terrain at 5-10% slope, these areas were counted if the pervious surface extended at least twice the contributing length and drained to an area with a slope less than 5% to account for potential microtopography variation and error.

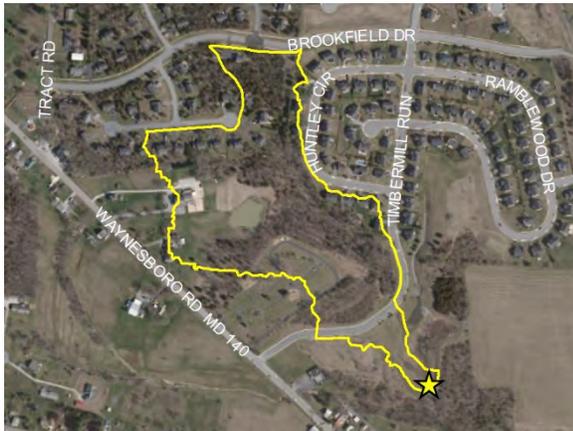
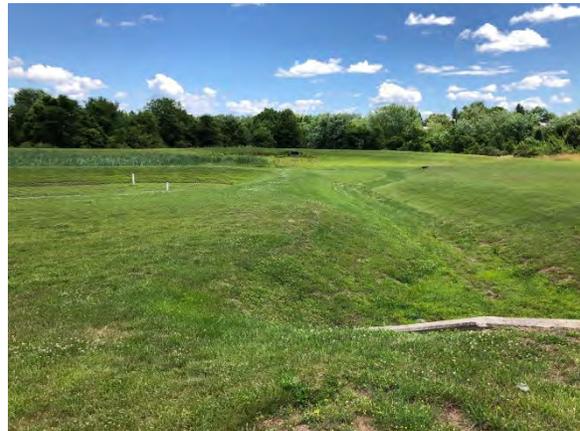
Brookfield Subdivision - Flood Pond (FR15POI000840)

The Brookfield subdivision flood pond was constructed in 1990. The design of this facility consisted of a large dry pond with multi-stage riser. Part of the footprint of the original facility was upgraded to a stormwater management BMP in 2012. This facility has a total drainage area of 26.24 acres and intercepts runoff from a portion of the Brookfield and Pembroke Woods subdivisions and several larger adjacent properties. Total untreated impervious within the drainage area is 2.52 acres.

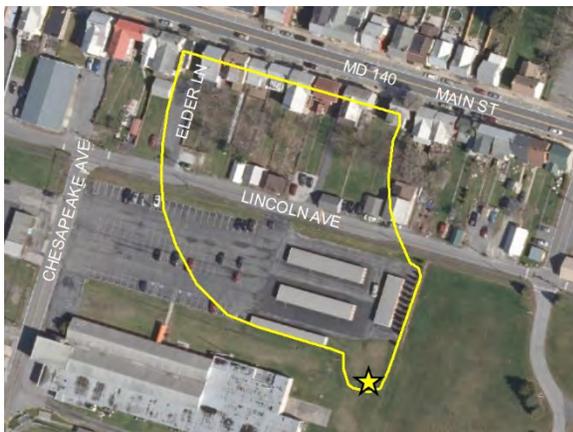
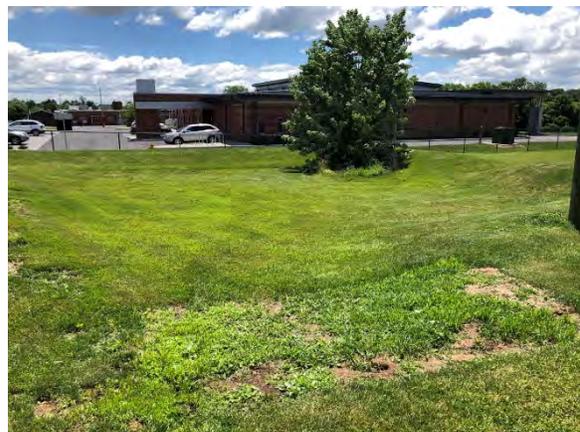
Emmitsburg Antique Mall (FR15POI000611)

The Emmitsburg Antique Mall pond was constructed in 2000. The design of this facility consisted of a dry pond with a grass overflow weir. This facility has a total drainage area of 2.29 acres and intercepts runoff from a portion of the Emmitsburg Antique Mall parking lot, a self-storage facility, and several residential properties. Total untreated impervious within the drainage area is 1.36 acres.

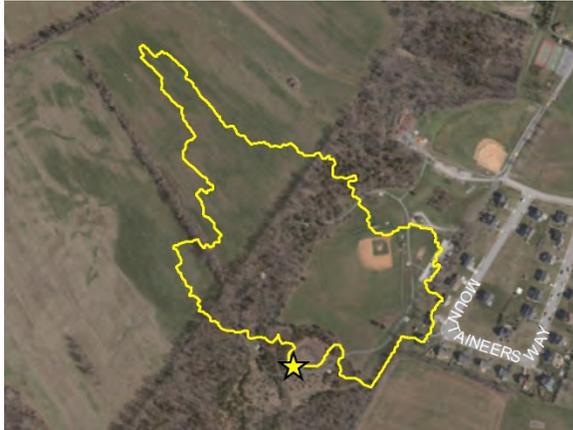
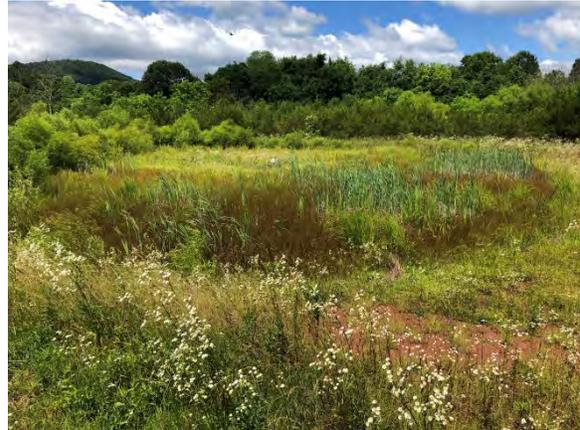
Emmitsburg Community Park, PH 1 -CPv Pond (FR15POI000920)

The Emmitsburg Community Park Phase 1 CPv pond was constructed in 2013. The design of this facility consisted of two wet ponds and an infiltration cell. This facility has a large drainage area of 17.39 acres, but only treats a small amount of park impervious including walking paths and gravel drives. Total untreated impervious within the drainage area is 0.51 acres, but most of this impervious is considered treated by nonstructural practices.

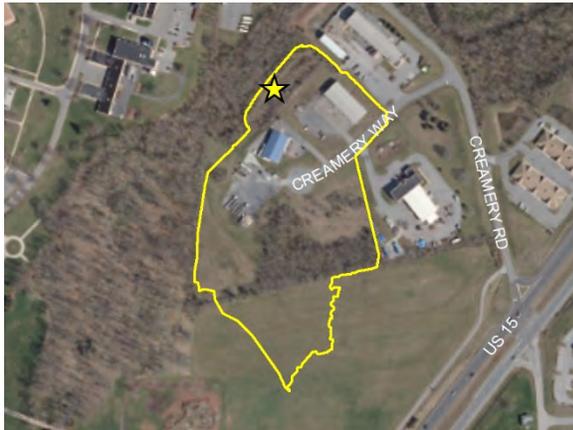
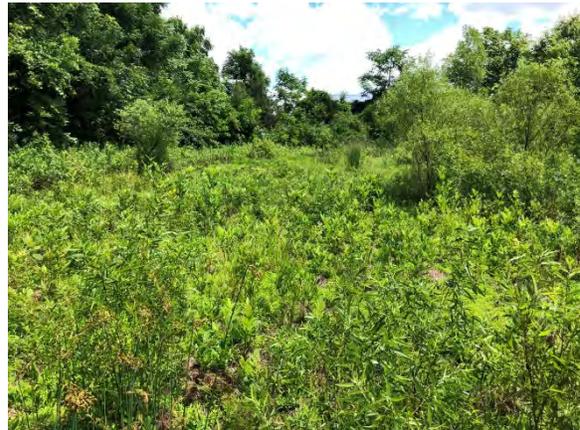
Emmitsburg East Industrial Park Lots 1-6 (FR15POI198649)

The Emmitsburg Panes extended detention pond #2 was constructed in 1996. The design of this facility consisted of a dry pond with multi-stage riser. This facility has a total drainage area of 10.99 acres and intercepts runoff from an industrial property. Total untreated impervious within the drainage area is 2.40 acres.

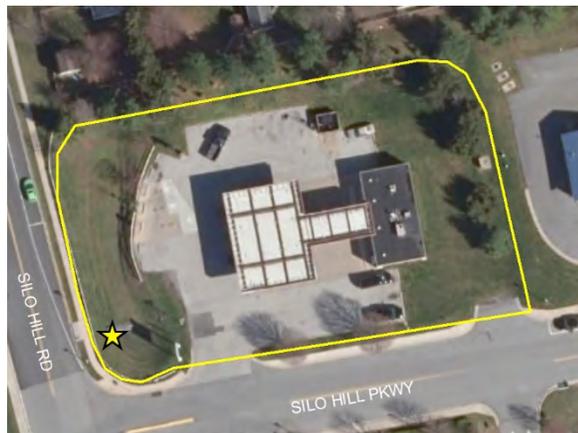
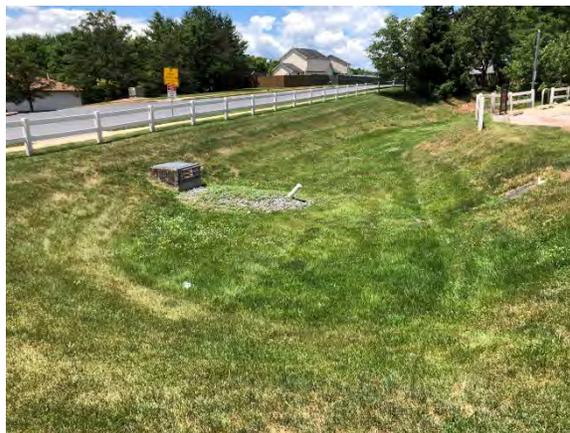
Emmitsburg Exxon (FR15POI000555)

The Emmitsburg Exxon extended detention pond was constructed in 1997. The design of this facility consisted of a dry pond with multi-stage riser. This facility has a total drainage area of 0.85 acres and intercepts runoff from the Exxon gas station. Total untreated impervious within the drainage area is 0.40 acres.

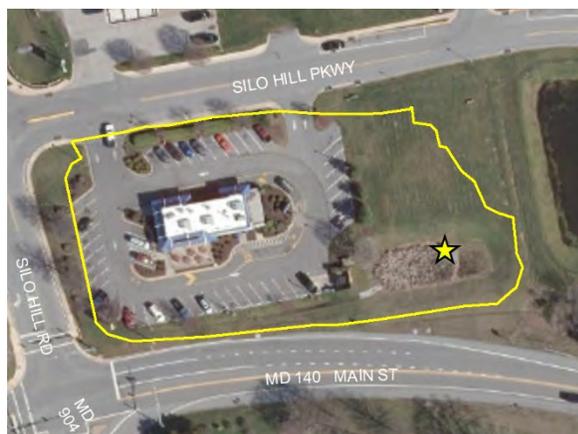
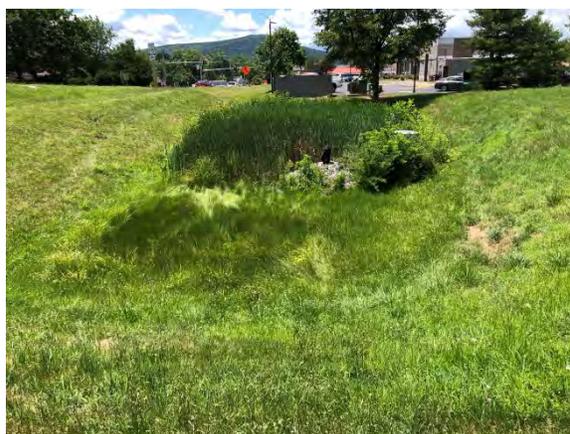
Emmitsburg McDonalds - ED Basin (FR15POI000339)

The Emmitsburg McDonald's extended detention pond was constructed in 1997. The design of this facility consisted of a dry pond with multi-stage riser. This facility has a total drainage area of 1.35 acres and intercepts runoff from the McDonald's building and parking lot. Total untreated impervious within the drainage area is 0.64 acres.

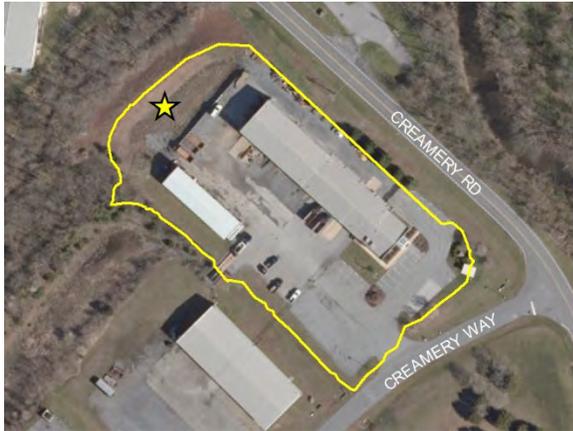
Emmitsburg Panes - ED Pond (FR15POI000483)

The Emmitsburg Panes extended detention pond #1 was constructed in 1996. The design of this facility consisted of a dry pond with multi-stage riser. This facility has a total drainage area of 2.14 acres and intercepts runoff from an industrial property. Total untreated impervious within the drainage area is 1.45 acres.

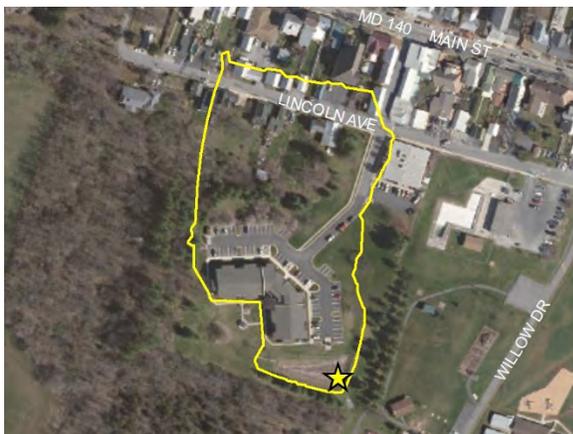
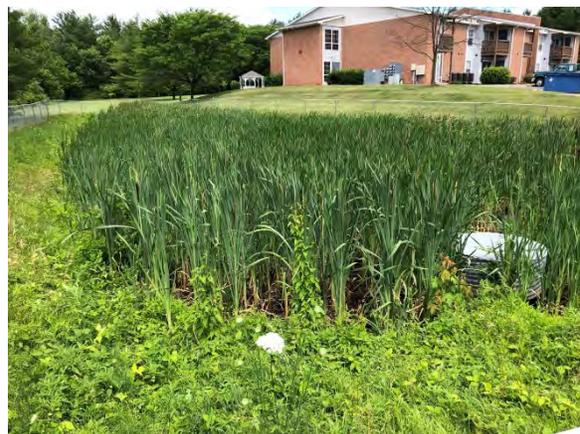
Lincoln on the Park ED Pond (FR15POI000368)

The Lincoln on the Park extended detention pond was constructed in 1991. The design of this facility consisted of a dry pond with multi-stage riser. This facility has a total drainage area of 4.66 acres and intercepts runoff from the Lincoln on the Park apartment complex property and portions of several adjacent residential properties. Total untreated impervious within the drainage area is 1.77 acres.

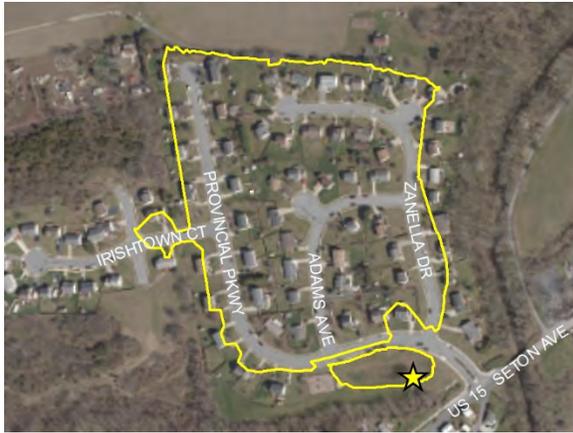
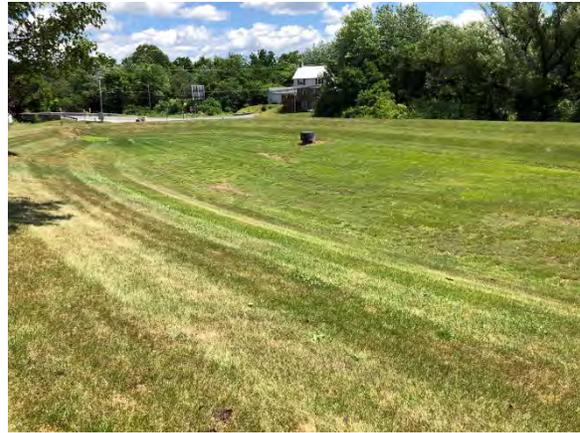
Northgate - Extended Detention Pond (FR15POI000140)

The Northgate extended detention pond #1 was constructed in 1994. The design of this facility consisted of a dry pond with multi-stage riser. This facility has a total drainage area of 17.31 acres and intercepts runoff from the Northgate subdivision. Total untreated impervious within the drainage area is 6.07 acres.

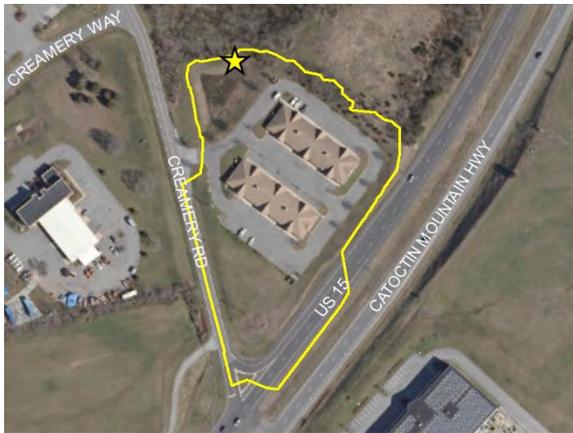
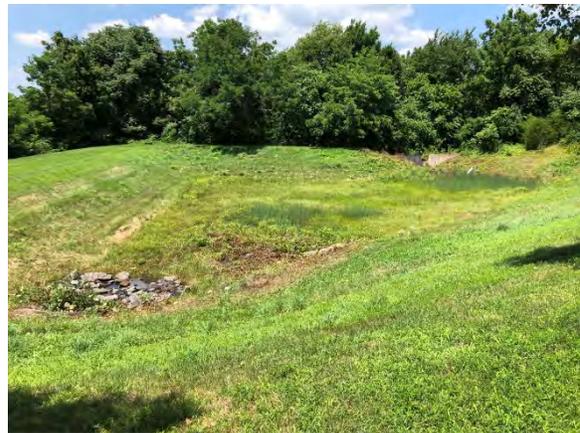
Seton Square Center (FR15POI000626)

The Seton Square Center extended detention pond was constructed in 2001. The design of this facility consisted of a dry pond with multi-stage riser. This facility has a total drainage area of 4.61 acres and intercepts runoff from the Seton Square Center commercial development. Total untreated impervious within the drainage area is 2.26 acres.

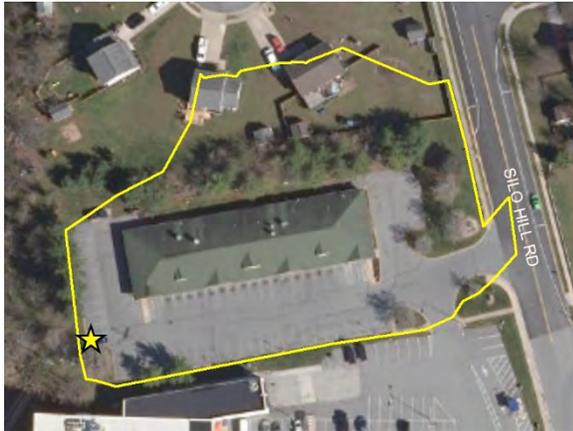
Silo Hill, OGS (FR15POI000337)

The Silo Hill oil-grit separator was constructed in 1997. The design featured a buried multi-cell concrete unit with sediment settling and oil separating cells. This facility has a total drainage area of 1.64 acres with including a shopping plaza and associated parking. Total untreated impervious within the drainage area is 0.93 acres.

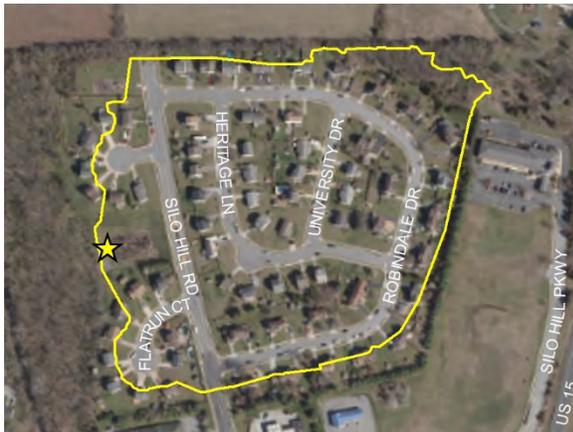
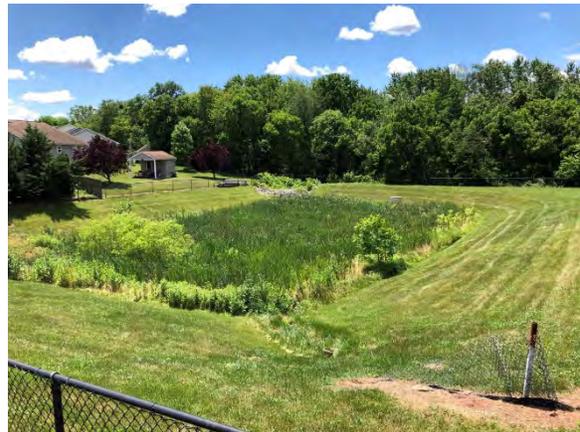
Silo Hill SWM Pond (FR15POI000531)

The Silo Hill extended detention pond was constructed in 2002. The design of this facility consisted of a dry pond with multi-stage riser, although the pond appears to be functionally wet. This facility has a total drainage area of 22.22 acres and intercepts runoff from the Silo Hill subdivision. Total untreated impervious within the drainage area is 7.96 acres.

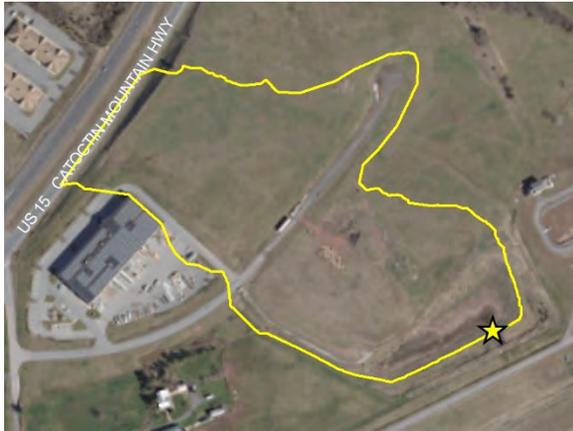
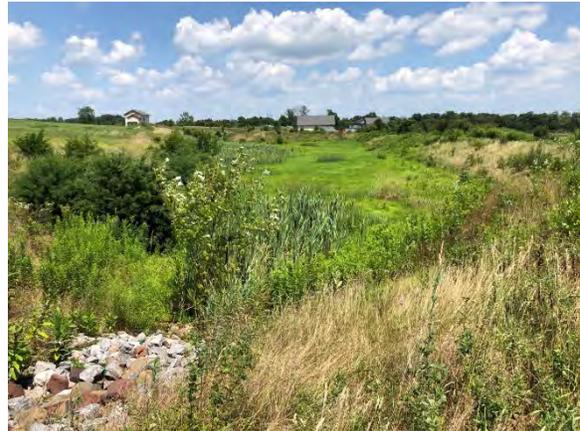
Emmitsburg East - Quantity Control Pond (FR16POI000720)

The Emmitsburg East (Waybright Property) quantity control pond was constructed in 1990. The design of this facility consisted of a large dry pond with a flood level control structure. This facility has a total drainage area of 17.39 acres and intercepts runoff from a small section of US 15 and a section of industrial park. Total untreated impervious within the drainage area is 1.31 acres.

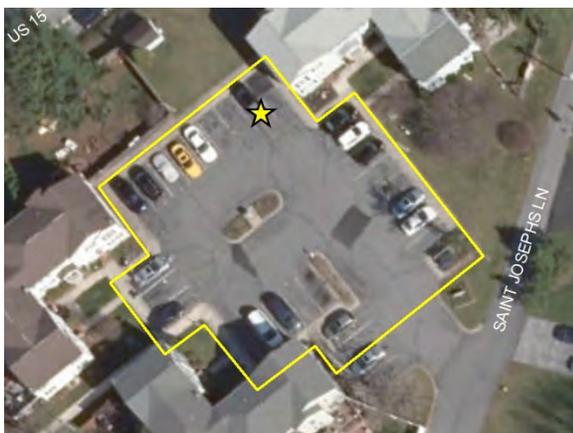
Seton Place – Infiltration Trench (FR15POI000137)

The Seton Place infiltration trench was constructed in 1992. The design of this facility consisted of an underground infiltration system under the Seton Place parking lot. This facility has a total drainage area of 0.30 acres and intercepts runoff from the Seton Place parking lot. Although the BMP treats the impervious surface within its drainage area, the drainage area lies completely within the drainage area intercepted by SHA storm drain structures and so is omitted from the Town calculations. The total impervious area treated is 0.29 acres.
